# TURNOVER STUDY

**KEG File: 19RS-0128**  
**July 9, 2019**

*Watercrest Community  
Association, Inc.  
19360 Nearpoint Drive  
Venice, FL 34292*

**RE: Watercrest Community Association, Inc.  
KEG Project No. 19RS-0128  
Professional Engineering Services – Association Turnover Report**

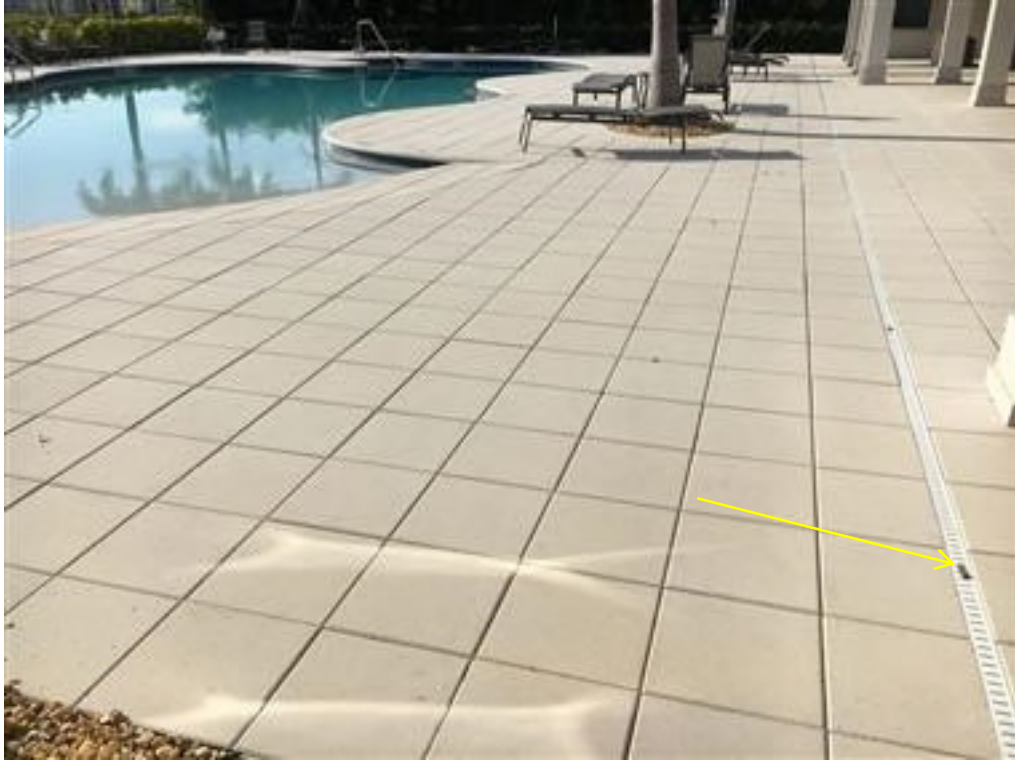
**Photo 8- pool pavers**

**Deco Drain;** the deco drain at the pool area has open joints and broken areas that should be addressed before they become a hazard and liability to the Owners.  
Photos 8, 9, 10, 11

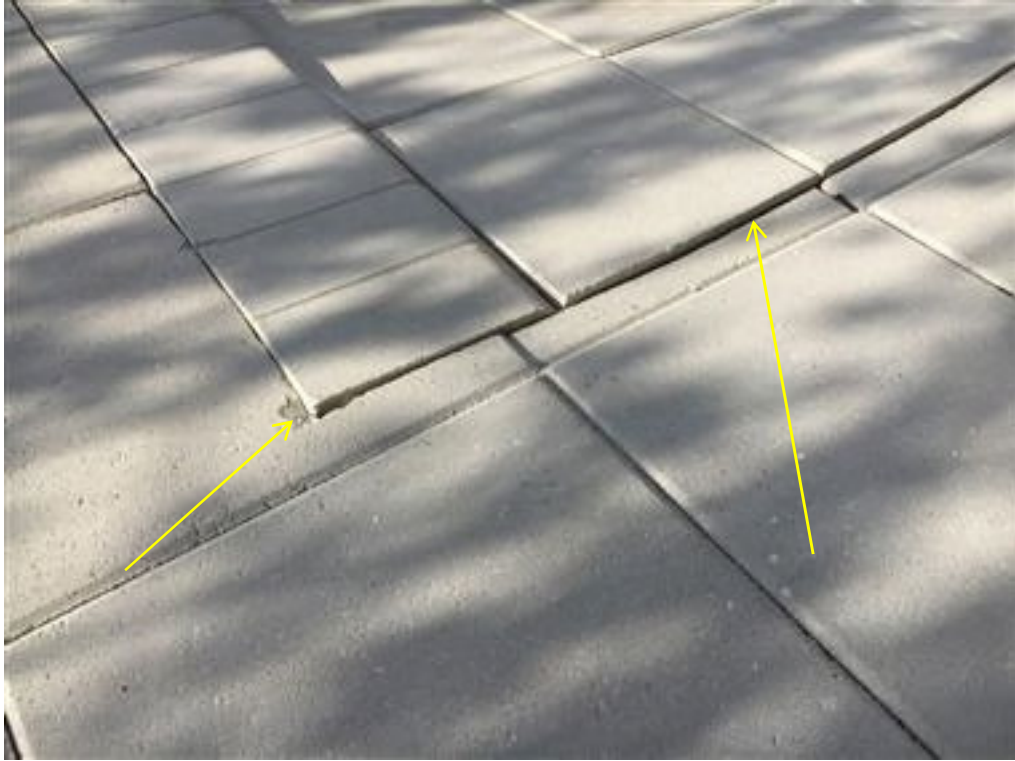
**Photo 12- pool pavers**

**1. Hazards; Trip Hazard At Pool Paver And At The Entrance Pavers**

*Commentary:* pavers, tile, and any uneven walk surfaces should be installed to minimize level changes resulting in trip hazards, including the pool areas.

The priority should be the trip hazard or safety issue at the pool area, which is a liability concern.

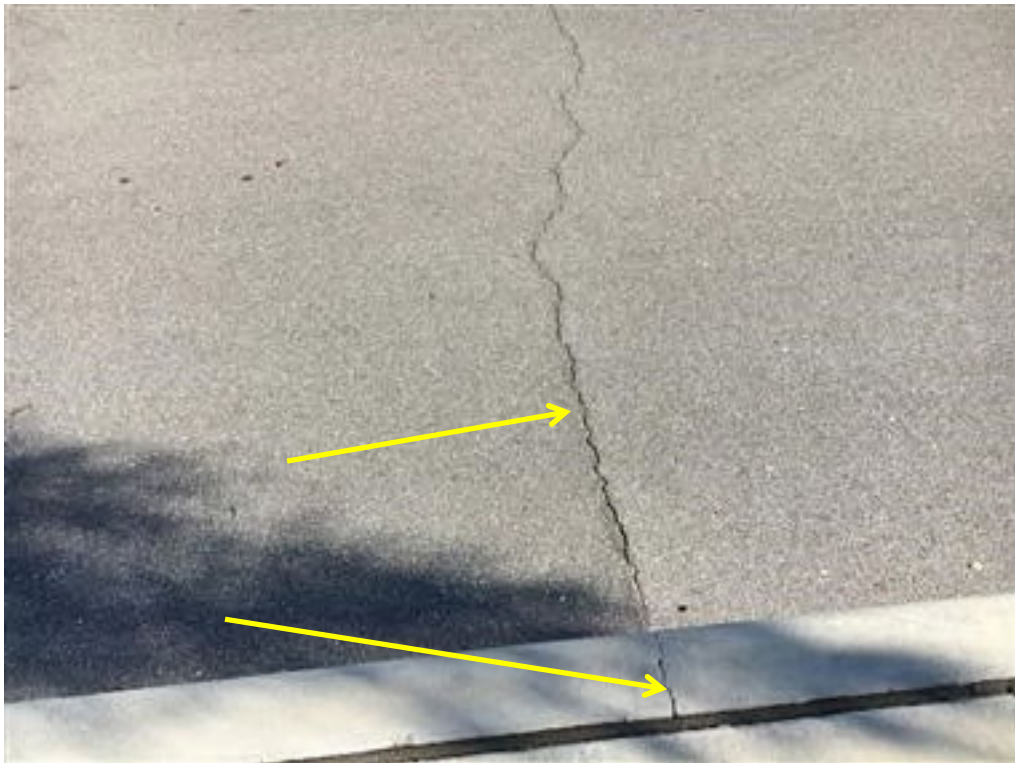
**Photo 55- asphalt parking, curb**

**5. Asphalt Pavement; Deterioration and Cracks**

*Commentary:* The general condition observed is not normal for this age asphalt.

The transverse asphalt cracking at Watercrest appears to be due to premature cooling of the hot asphalt, which happens when the outside air temperature cools down too fast, preventing the new hot asphalt from cooling naturally. This premature cooling causing the binder to harden thus leading to surface cracks.

The cracks Karins observed are less than 3 mm. These cracks should receive a good quality crack filler to prevent water intrusion. We suggest the Client monitors them and if they don’t get any larger over the next 12 months, this may not be a major problem. If the cracks widen to greater than the 3mm thickness, then the cracks should be addressed.

Recommended maintenance includes sealing at five-year intervals to minimize the raveling. The areas of improper slope should be addressed.

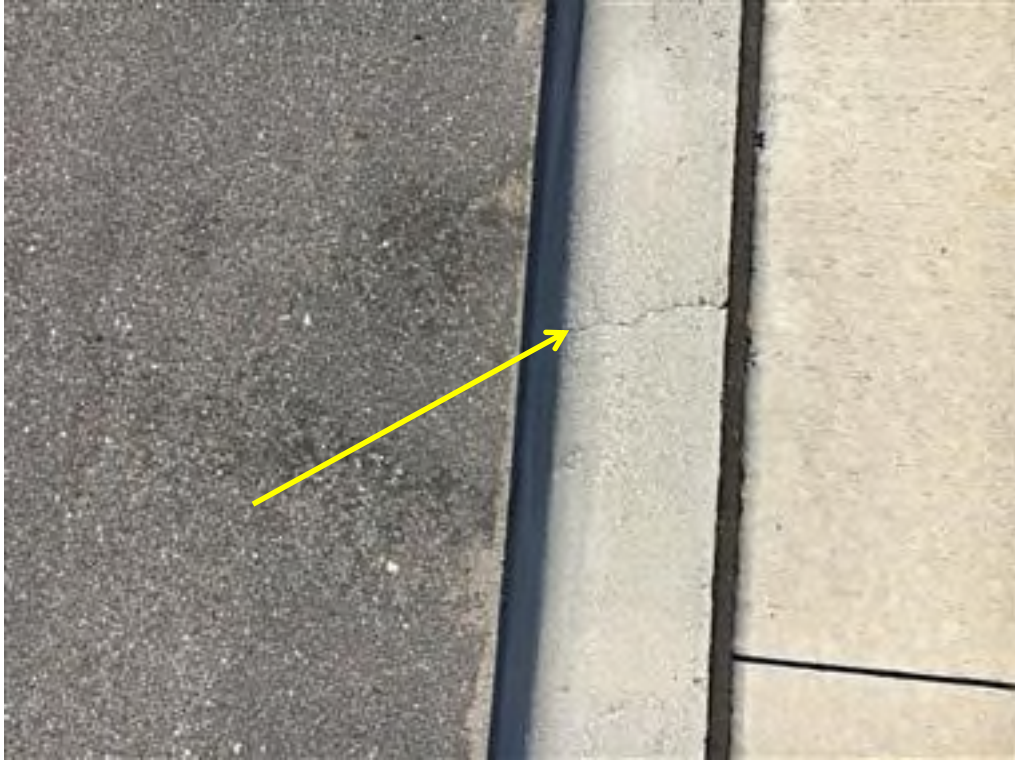
**Photo 56- curb**

**6. Concrete; Cracks And Deterioration; Various Locations.**

*Commentary:* The cracking of the concrete may be the result of a failure to follow the code adopted standards for finishing, curing and jointing the concrete, along with design and control of concrete mixtures and/or construction traffic damage. The sidewalk finish varies greatly and some sections appear to have been rained on before setting. The finishes should comply with ACI-318.

The broken curb areas should be replaced. It appears that a majority of the curb damage is likely caused by construction and roll off dumpsters.

All cracked areas of concrete should be addressed.

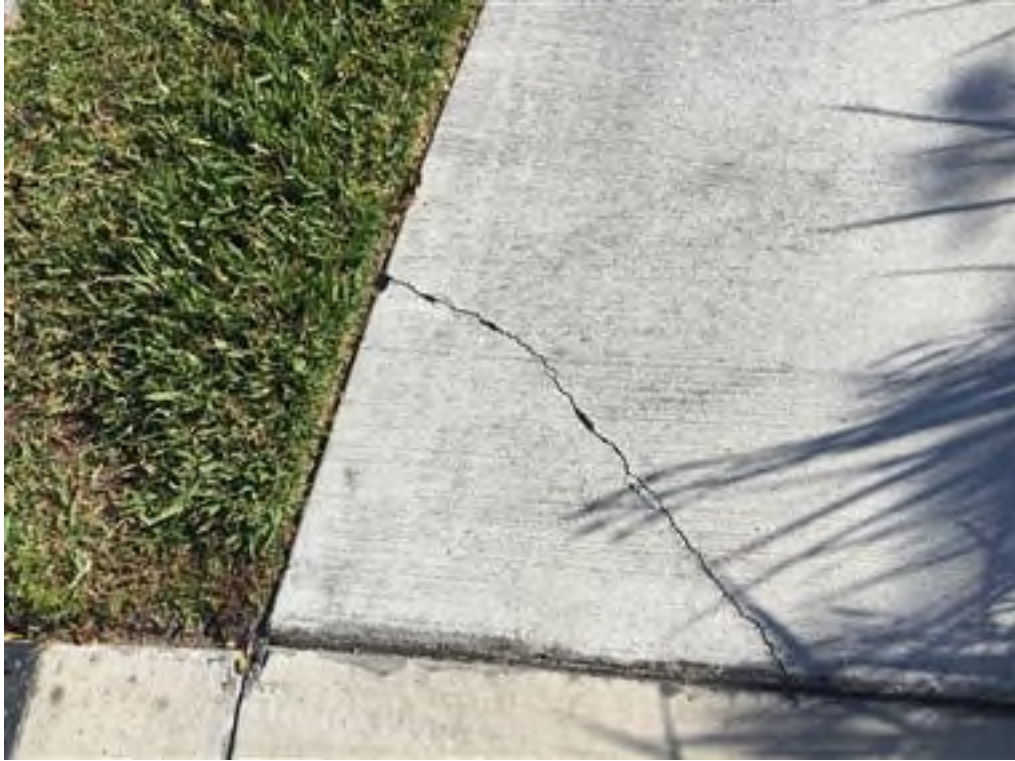
**Photo 62- sidewalk near clubhouse**

There is a crack at the guardhouse door slab along with cracks at sidewalks and curbs.

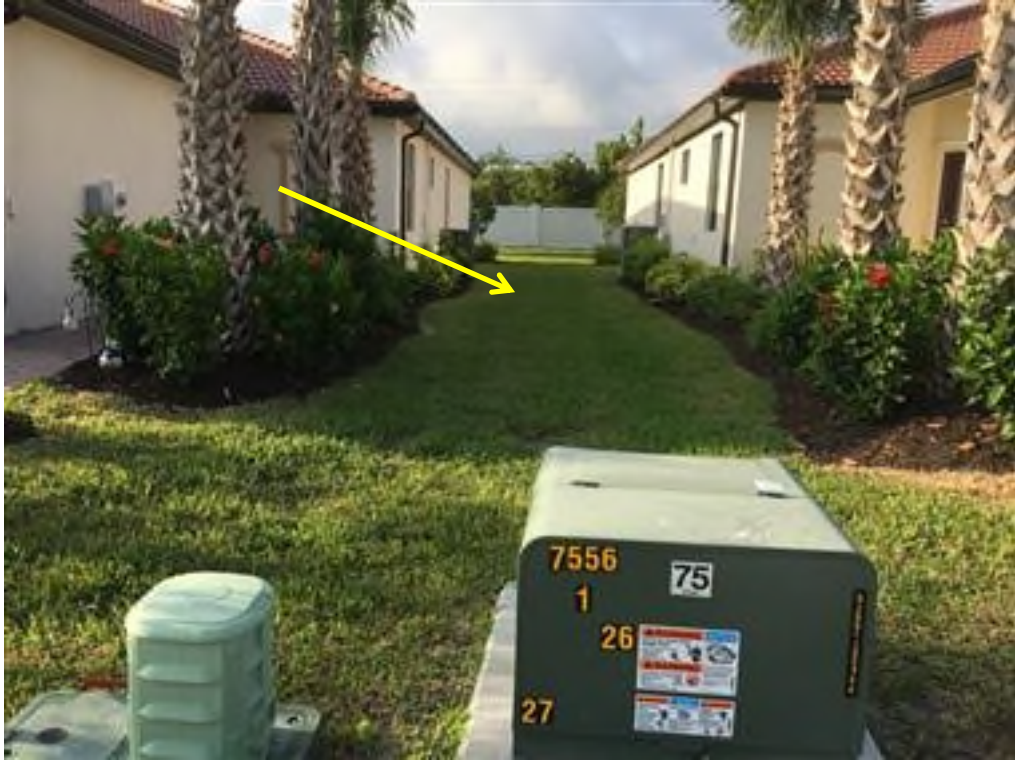
Photo 88- swale area 9851-9847 Haze Drive

#### **4. Drainage and Grade; Improper Slope At Swales Between Buildings**

*Commentary:* the plans show 10' minimum building separation and a 1 in 6 slope starting at six inches below the finished floor.

Standing water from downspouts, irrigation lines, and A/C condensate lines causes erosion of soils, uncontrolled water causes moisture intrusion into exterior walls, damaging interior and exterior finishes, contributing to the growth of mold.

The lack of proper grade away from the structures appears at a majority of the observed locations. The Owners may elect to have a survey performed to confirm the quantities and locations of all of the improper grade locations between the buildings.

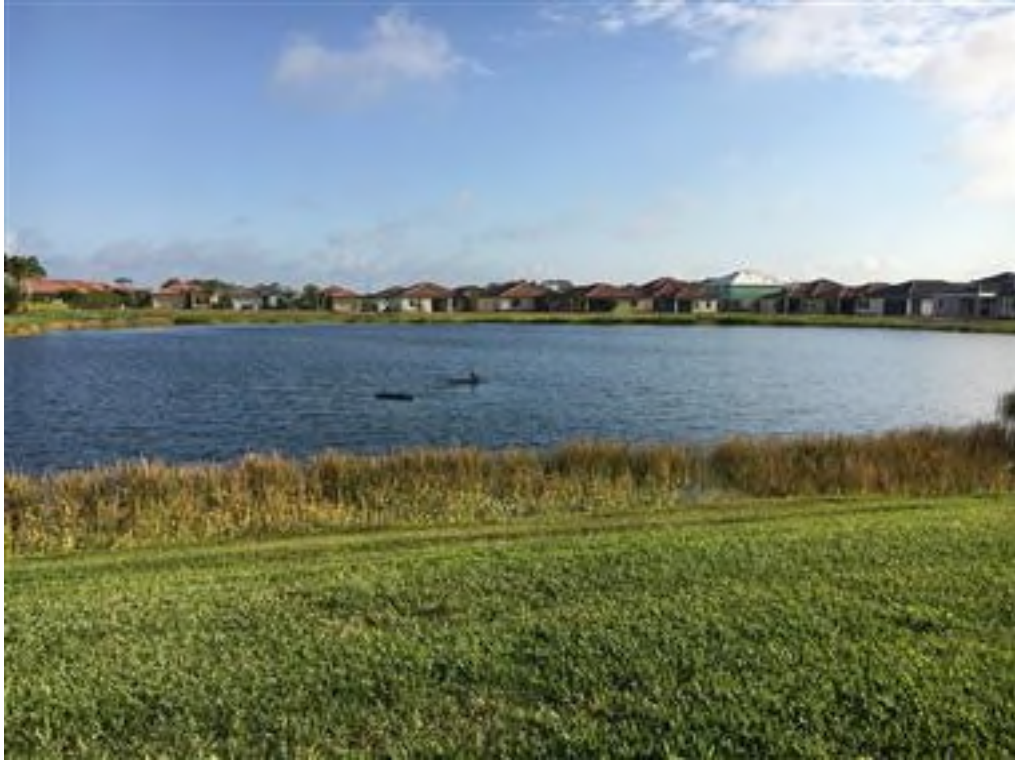
**Photo 98- lake, typical**

**Pond & Wetland;** appears in good/average condition. A maintenance contract should be in place.  
Photos 109, 98

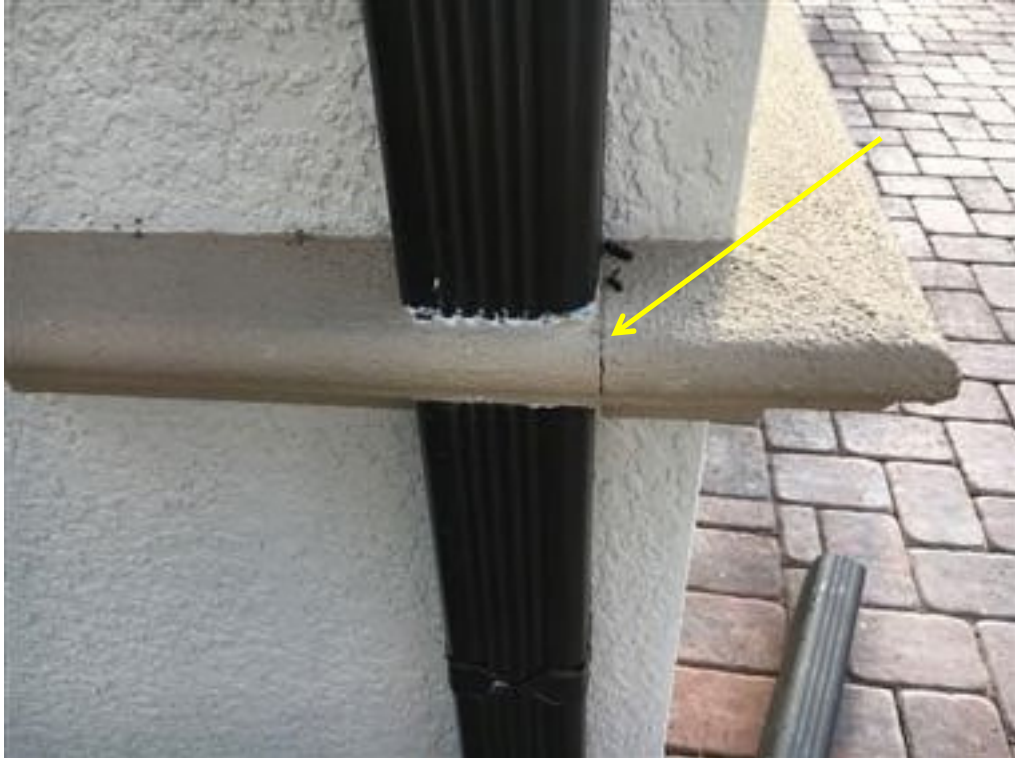
**Photo 101- open trim joint 9836 Haze Drive**

**2. Sealants (Caulk), Missing, Improper Application At Window And Door Perimeters**

*Commentary:* The improper sealant joint configurations do not comply with the referenced design considerations to prevent entry of water. The industry standard for application of sealants requires that the sealant material be no less than ¼” thick at each surface. This would provide a minimum ½” face width on all caulk/sealant joints. In addition, an area of separation (to receive the sealant) between the perimeters and the stucco or trim is required. Window and door frames exhibit minimal or improper sealant application at their perimeters. This will allow water intrusion into the structure and building interior.

The hairline cracks at the stucco surfaces should be addressed as part of the repainting Project.
