# TURNOVER STUDY

**KEG File: 19RS-0128**  
**July 9, 2019**

*Watercrest Community  
Association, Inc.  
19360 Nearpoint Drive  
Venice, FL 34292*

**RE: Watercrest Community Association, Inc.  
KEG Project No. 19RS-0128  
Professional Engineering Services – Association Turnover Report**

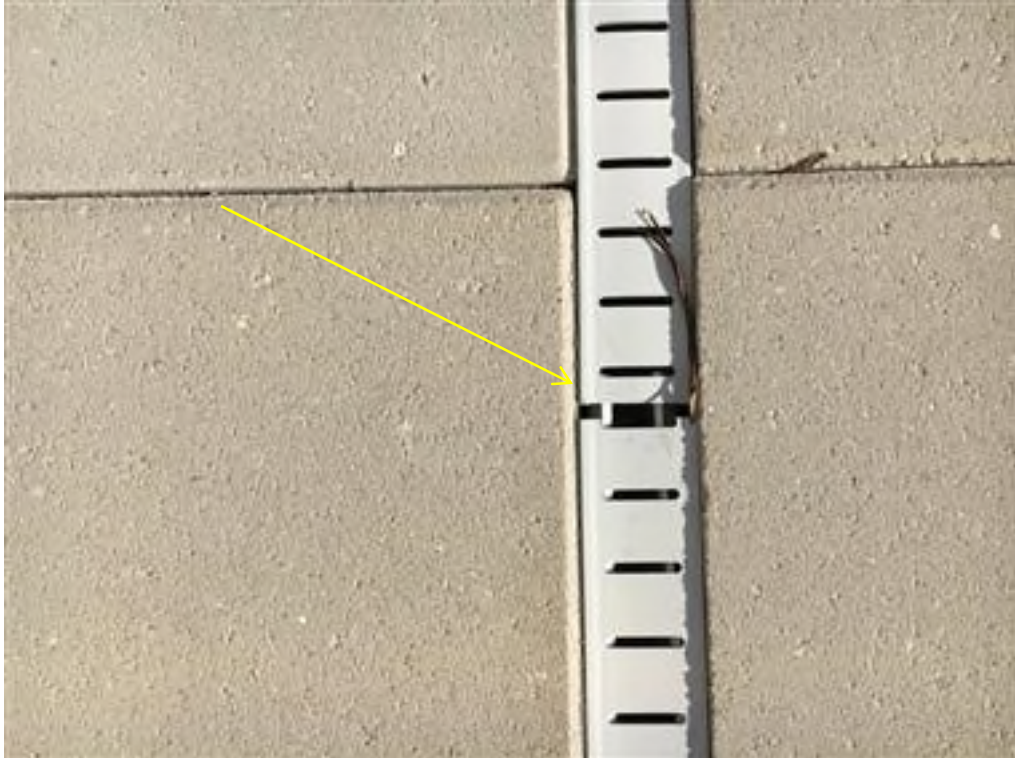
**Photo 9- pool deco drain**

**Deco Drain;** the deco drain at the pool area has open joints and broken areas that should be addressed before they become a hazard and liability to the Owners.  
Photos 8, 9, 10, 11

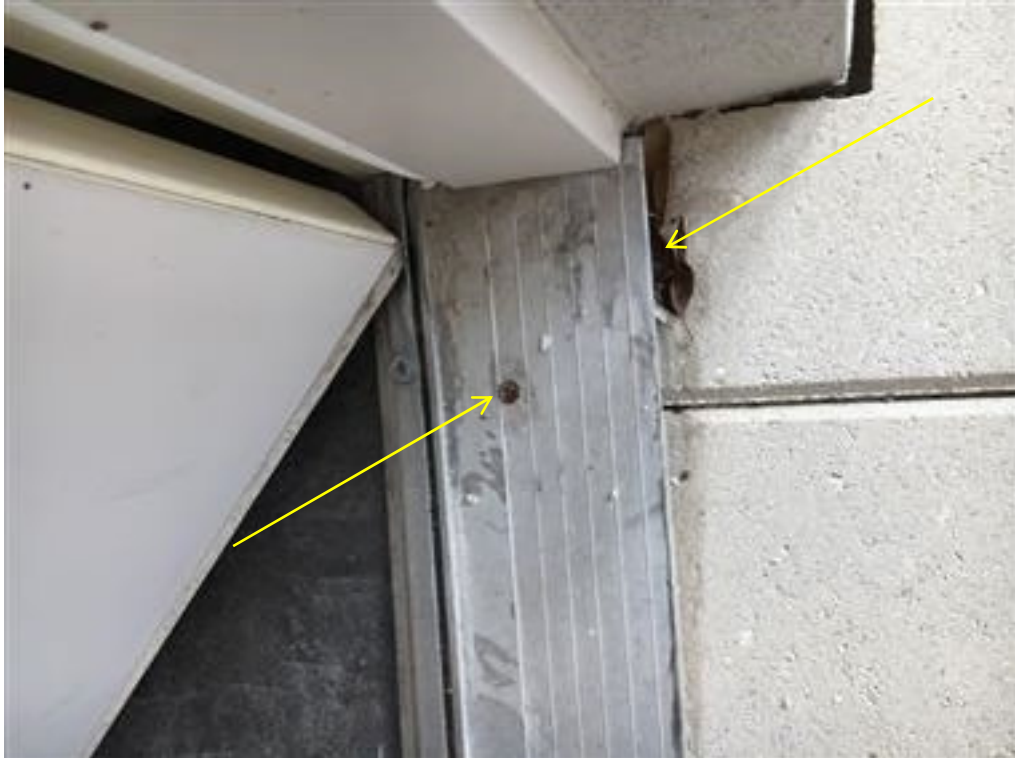
**Photo 27- pool area restroom**

**Thresholds;** The clubhouse restrooms have improperly installed thresholds. They should be installed in a bed of sealant with the proper non-ferrous fasteners.  
Photos 27, 31

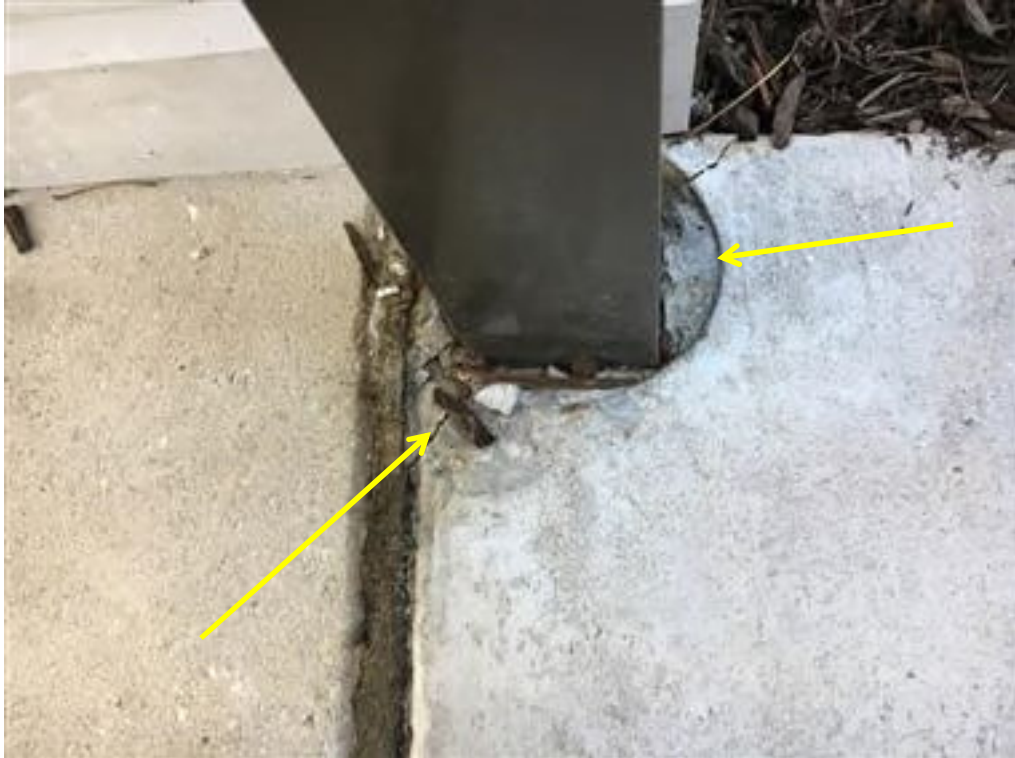
**Gates and Fence/Railings; Improper Post Pockets at Pool Gate;** the gateposts at the pool area are mounted with improperly filled post pockets. This will reduce the useful life expectancy of the posts and the concrete slabs. The loose posts will affect the gate performance. The gates should be maintained as functional. Many areas of loose railing pickets were observed.  
Photos 39, 42

**Photo 39- gate post pocket**

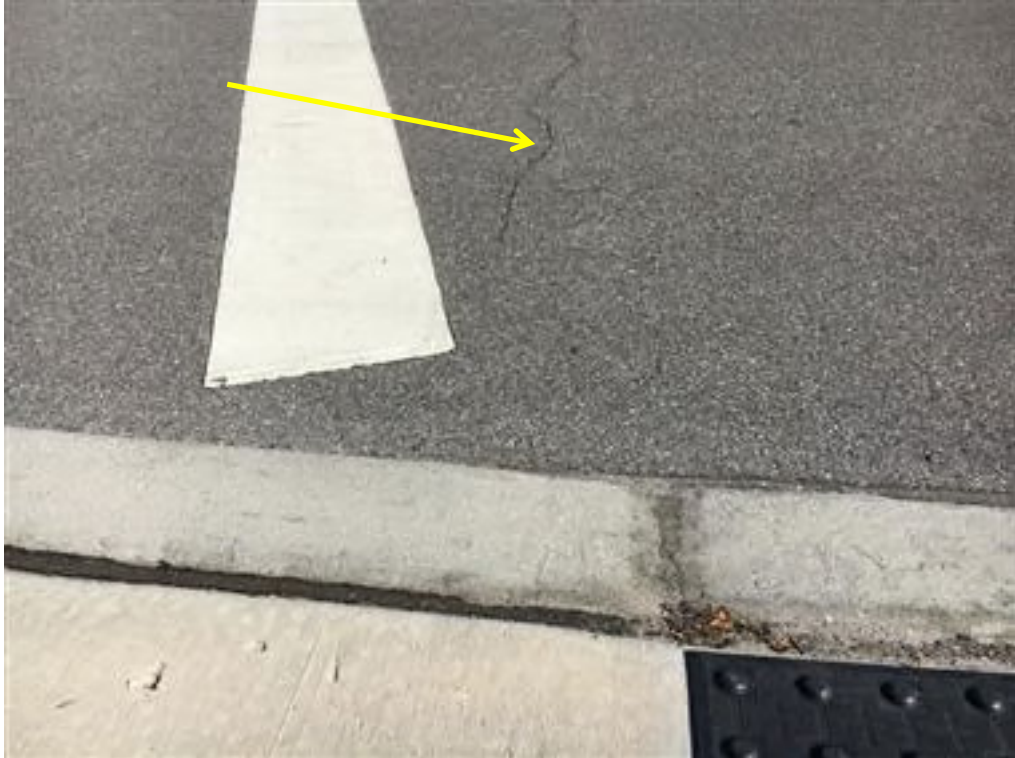
This condition appears to be systemic throughout the Project.

Reference Photos 56, 57, 62, 77, 78, 86, 89, 130

**Photo 56- curb**

All cracked areas of concrete should be addressed.

The concrete pre-cast walls at the Project perimeter should have all cracks filled to prevent moisture intrusion into the wall structure.

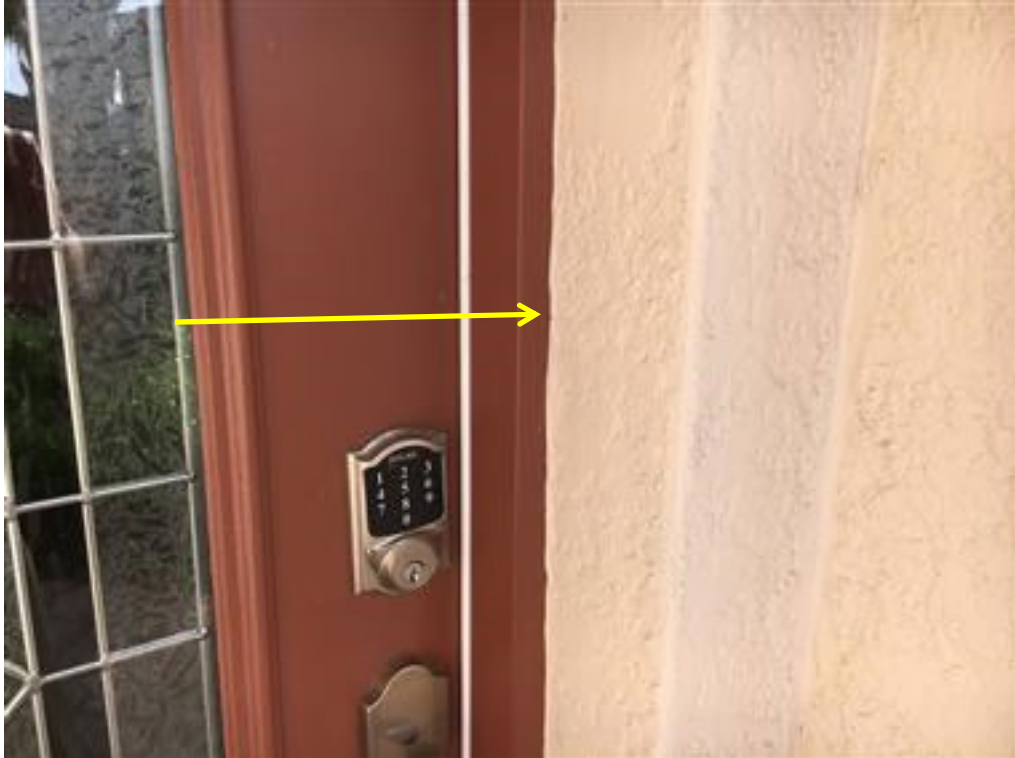
Reference Photos 101, 102, 103

**Photo 102- open trim joint 9832 Haze Drive**
