# TURNOVER STUDY

**KEG File: 19RS-0128**  
**July 9, 2019**

*Watercrest Community  
Association, Inc.  
19360 Nearpoint Drive  
Venice, FL 34292*

**RE: Watercrest Community Association, Inc.  
KEG Project No. 19RS-0128  
Professional Engineering Services – Association Turnover Report**

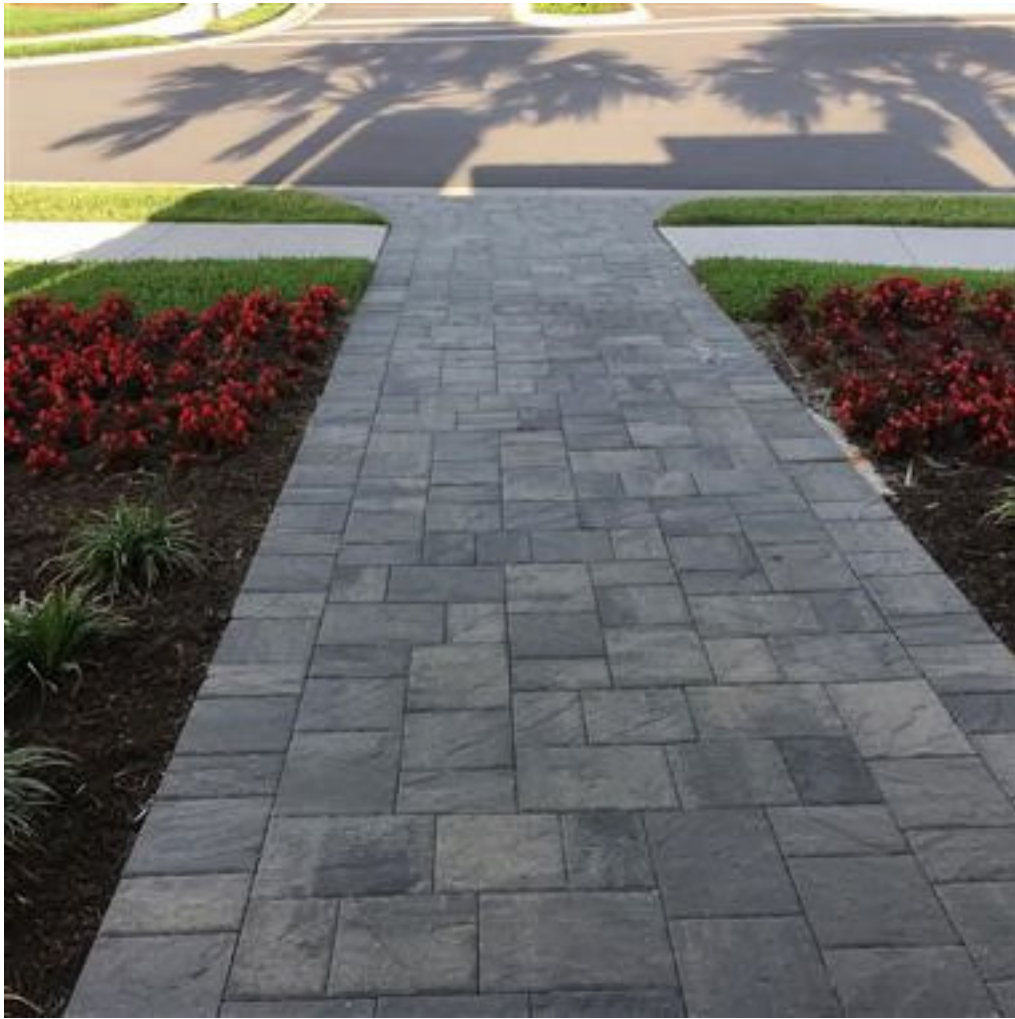
**Photo 4- pavers**

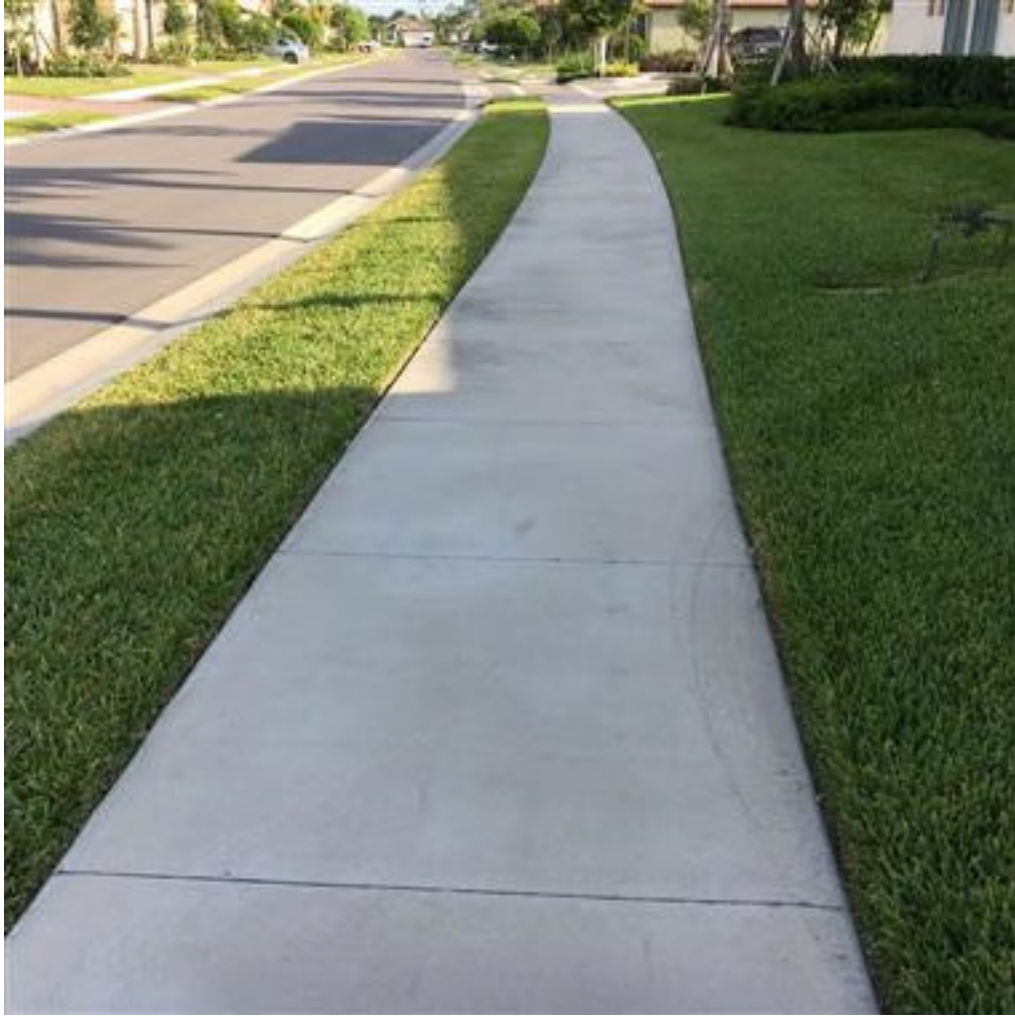
**Photo 5- sidewalk**

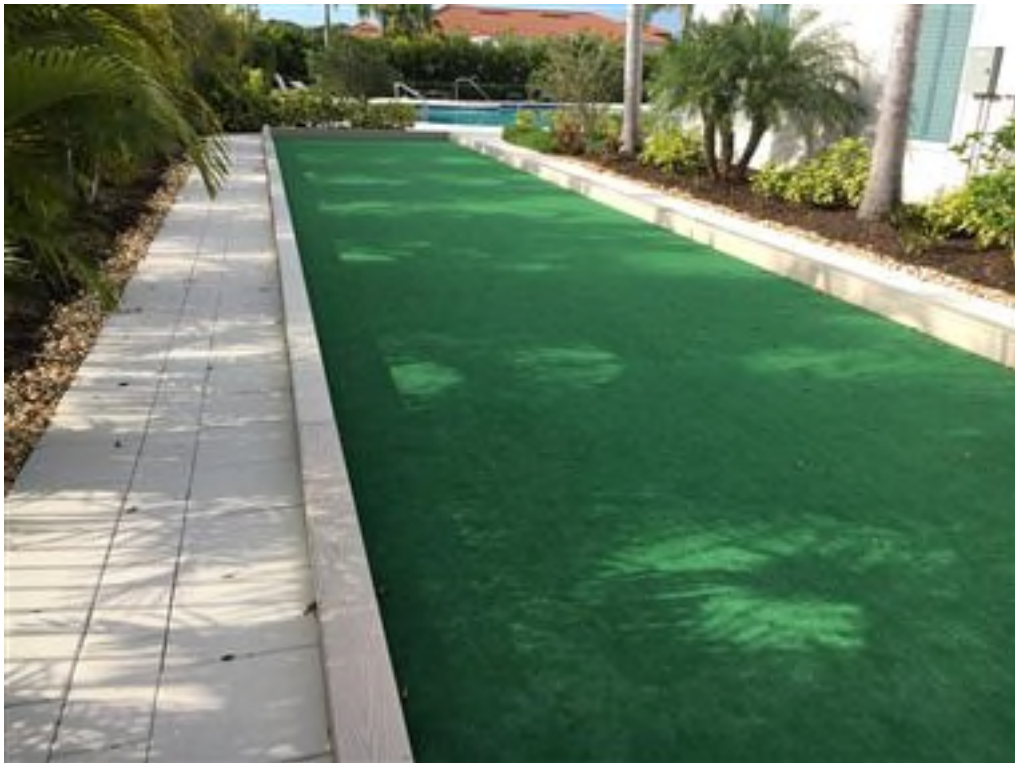
**Photo 15- green**

**Trim;** the trim boards at the “green” area have open joints and ferrous fasteners which will become a maintenance issue and shorten the expected useful life of the structure. .  
Photo 15, 16, 17

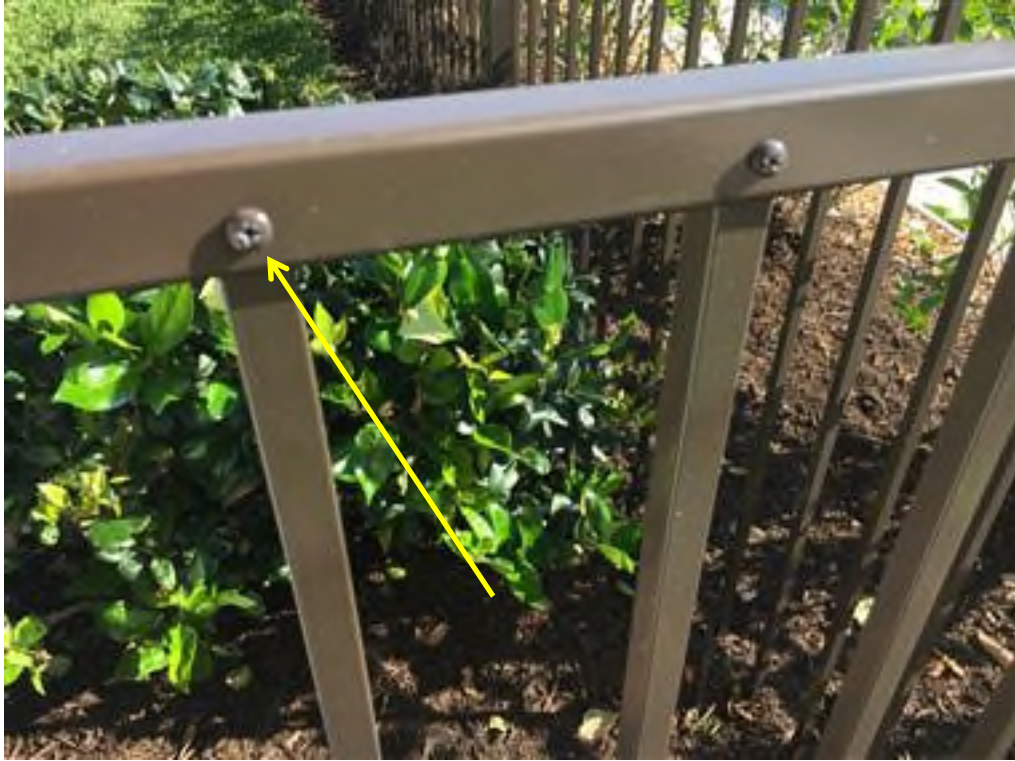
**Gates and Fence/Railings; Improper Post Pockets at Pool Gate;** the gateposts at the pool area are mounted with improperly filled post pockets. This will reduce the useful life expectancy of the posts and the concrete slabs. The loose posts will affect the gate performance. The gates should be maintained as functional. Many areas of loose railing pickets were observed.  
Photos 39, 42

**Photo 42-aluminium pool fence**

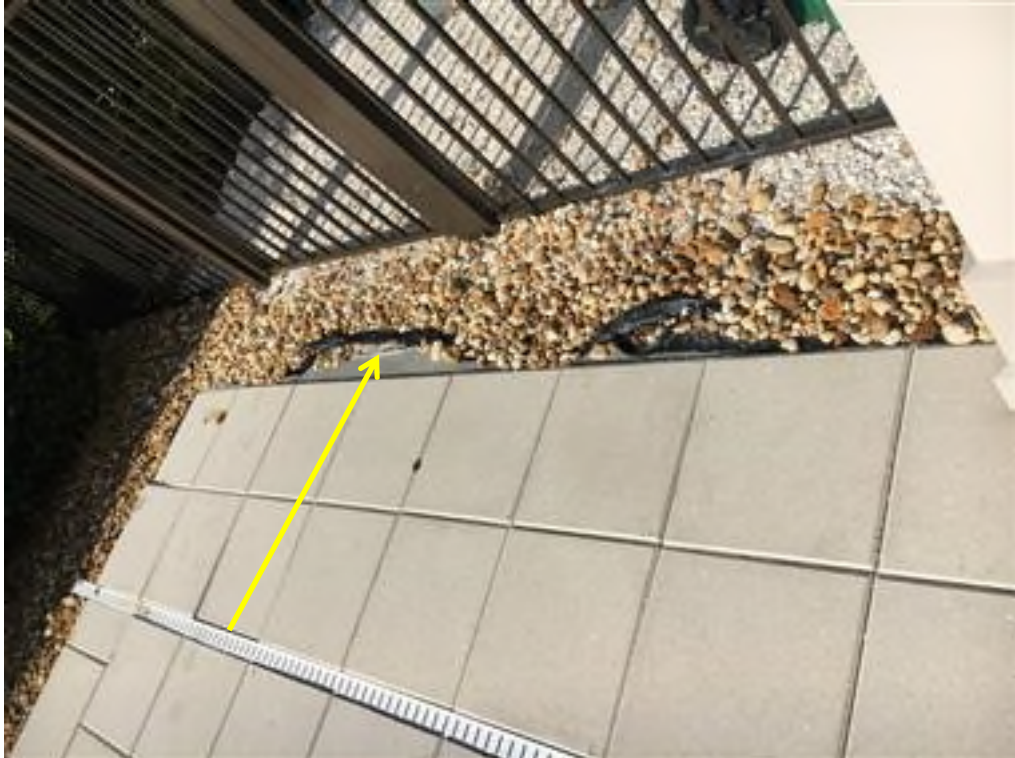
**Erosion;** the erosion at the pool equipment area and by unit 9855 should be addressed.  
Photos 43, 48, 83

**Photo 43- erosion**

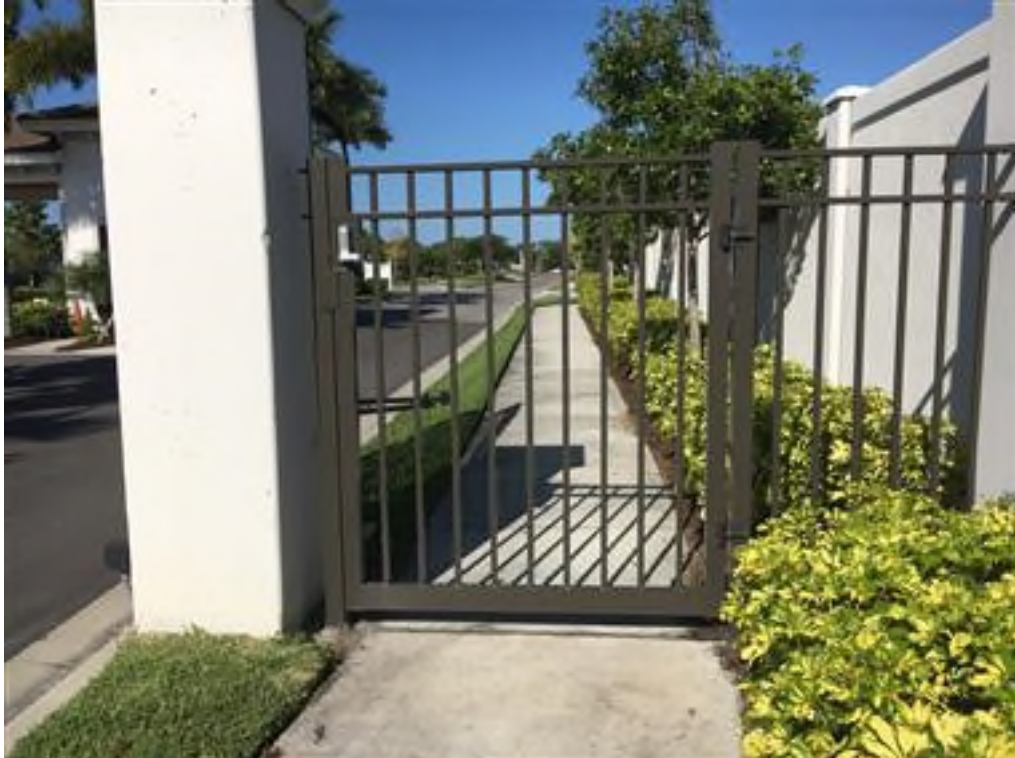
Reference Photos 64, 94, 95, 96, 97, 99, 100,105

**Photo 64- rusted fasteners**

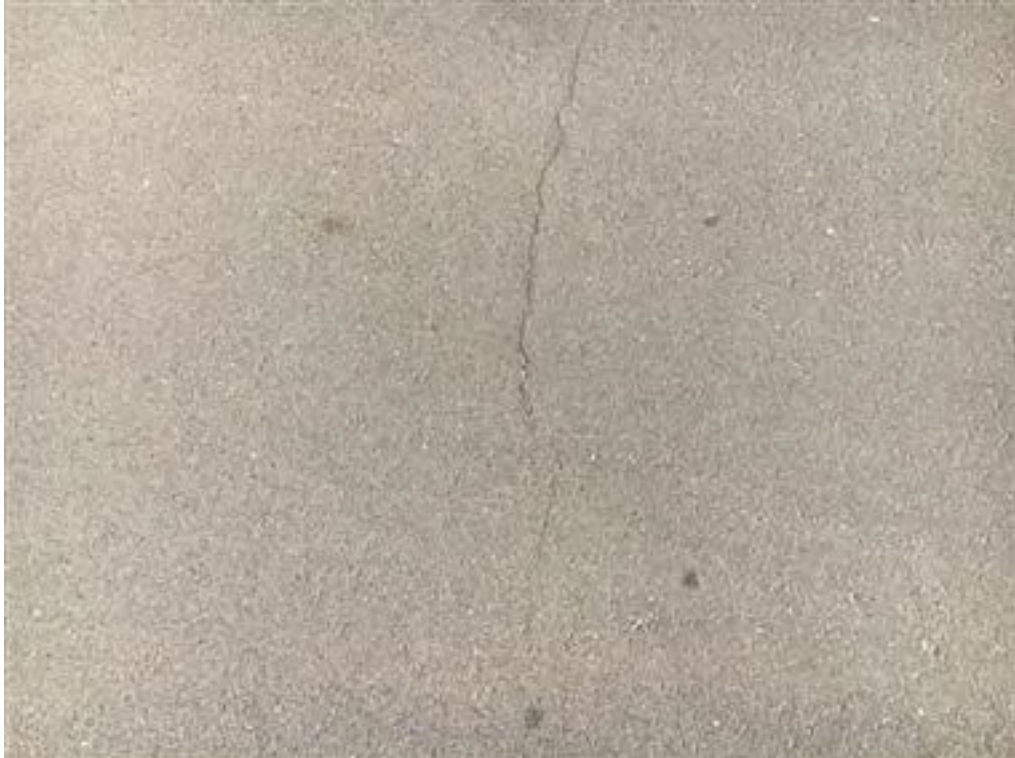
This condition appears to be systemic throughout the Project.

Reference Photos 56, 57, 62, 77, 78, 86, 89, 130

**Photo 86- concrete curb, typical**

All cracked areas of concrete should be addressed.

The concrete pre-cast walls at the Project perimeter should have all cracks filled to prevent moisture intrusion into the wall structure.

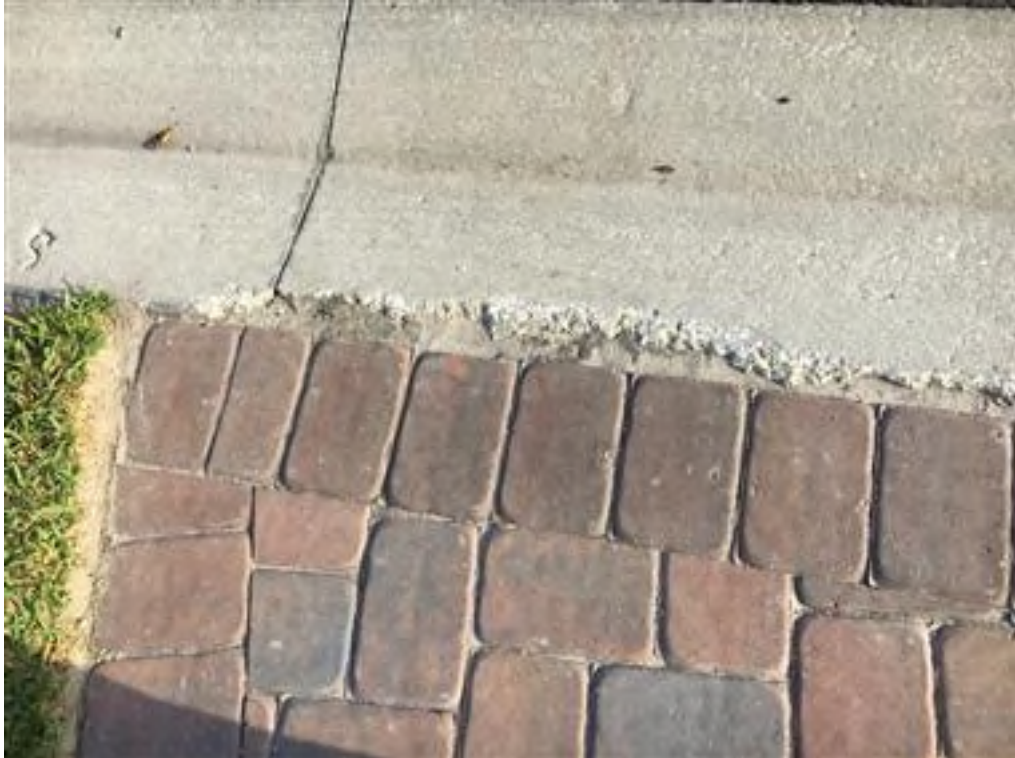
Reference Photos 88, 124, 126, 127

Photo 88- swale area 9851-9847 Haze Drive

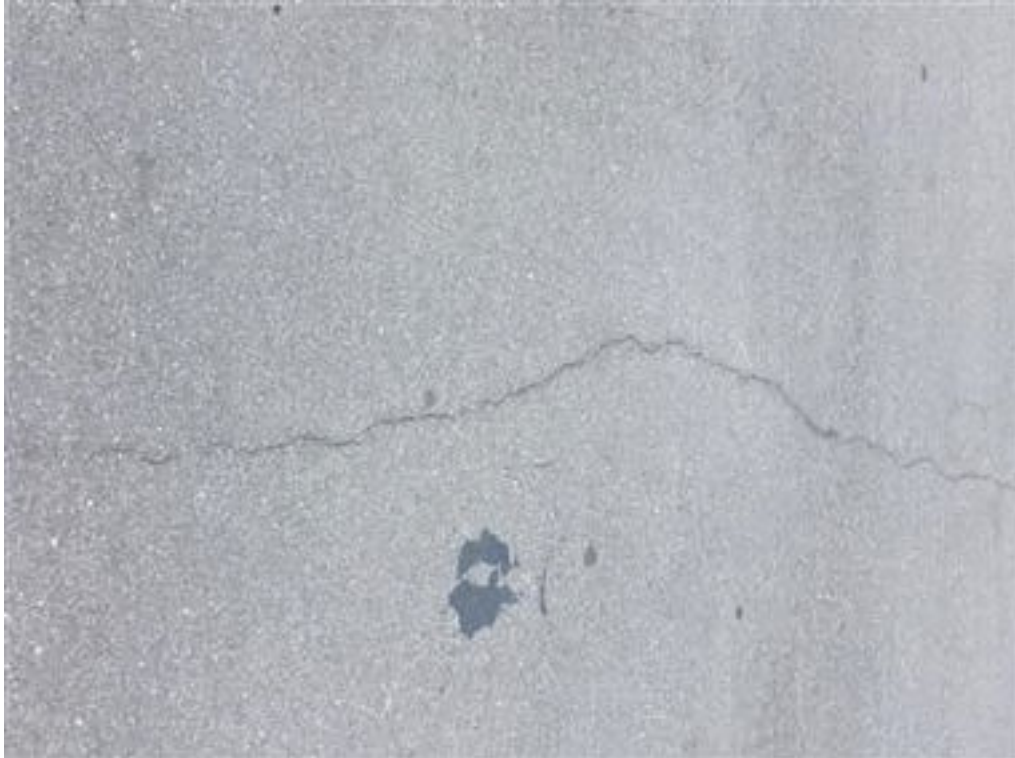
**Photo 110- asphalt paving**

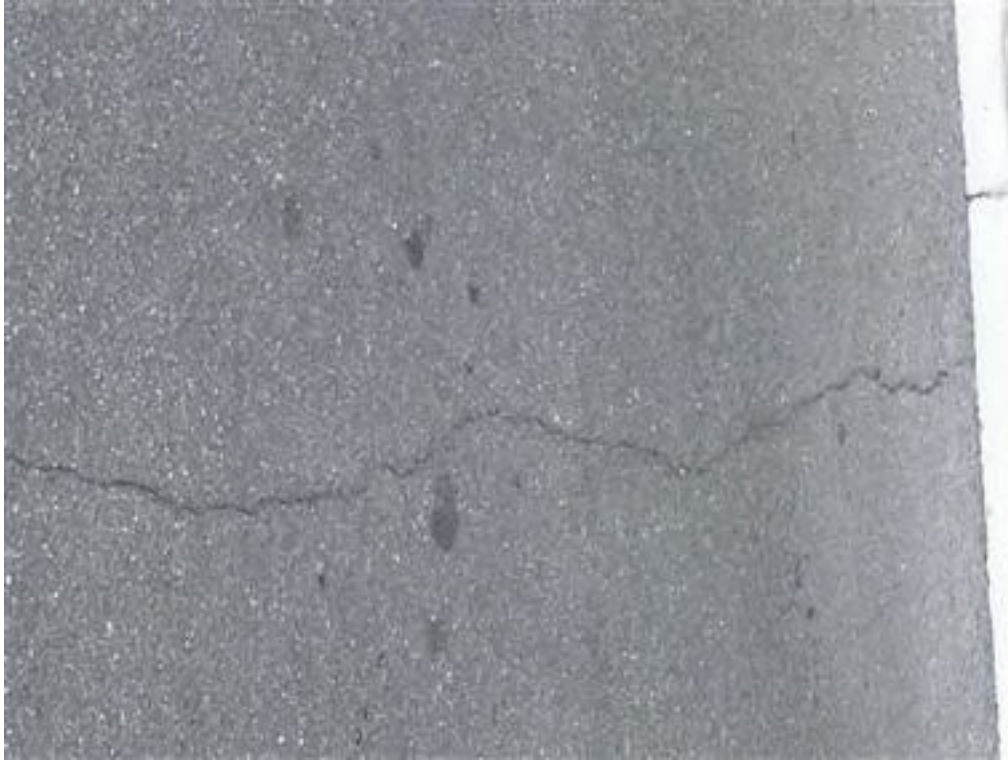
**Photo 111- asphalt paving**

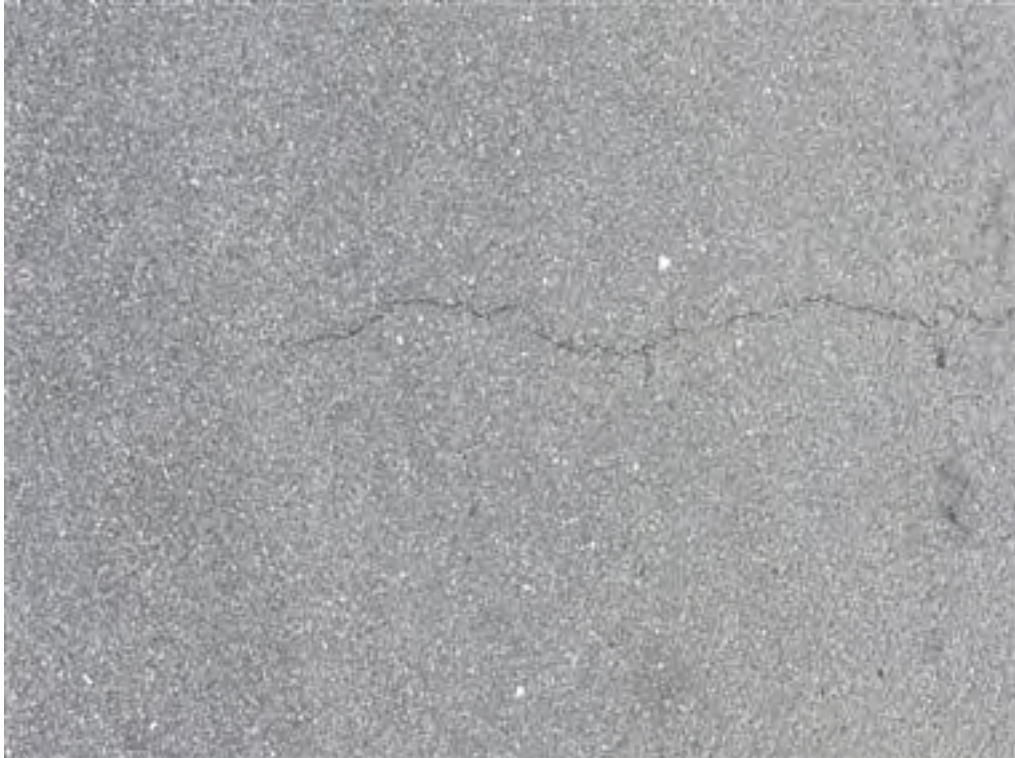
**Photo 112- asphalt paving**

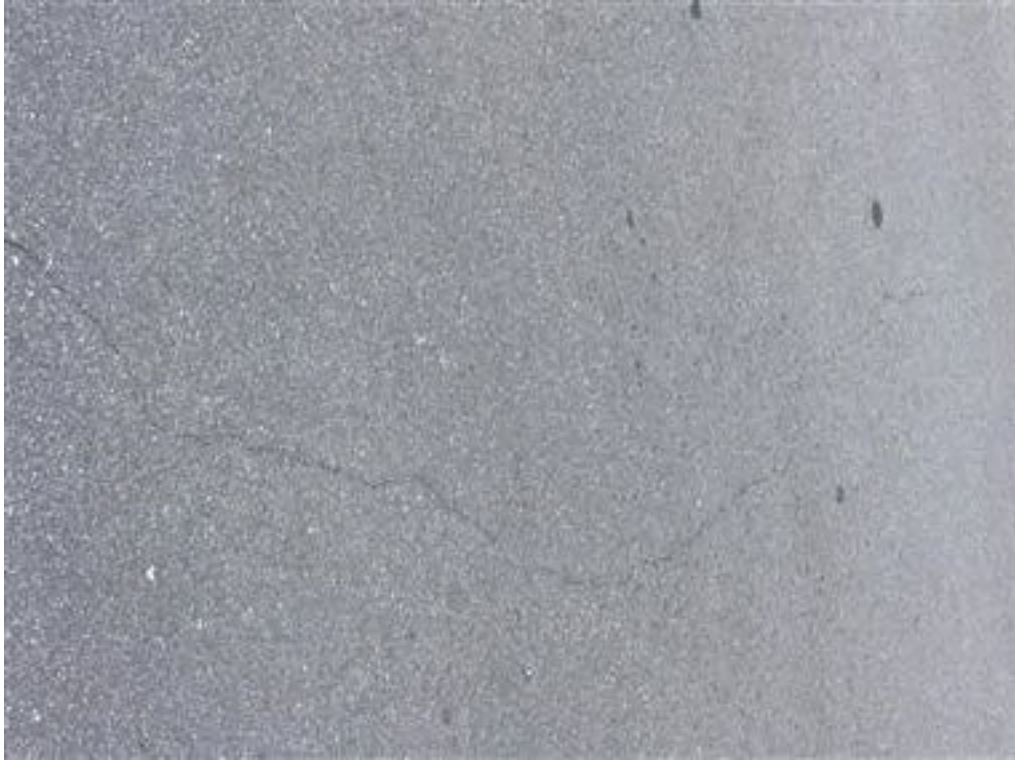
**Photo 113- asphalt paving**

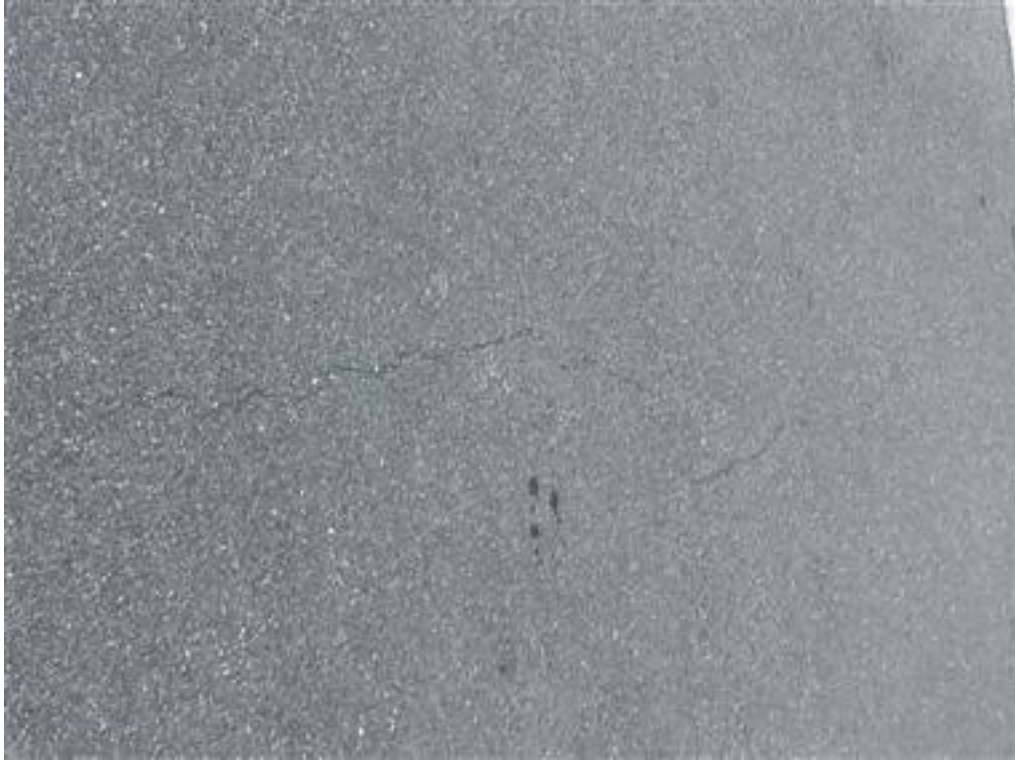
**Photo 115- asphalt paving**

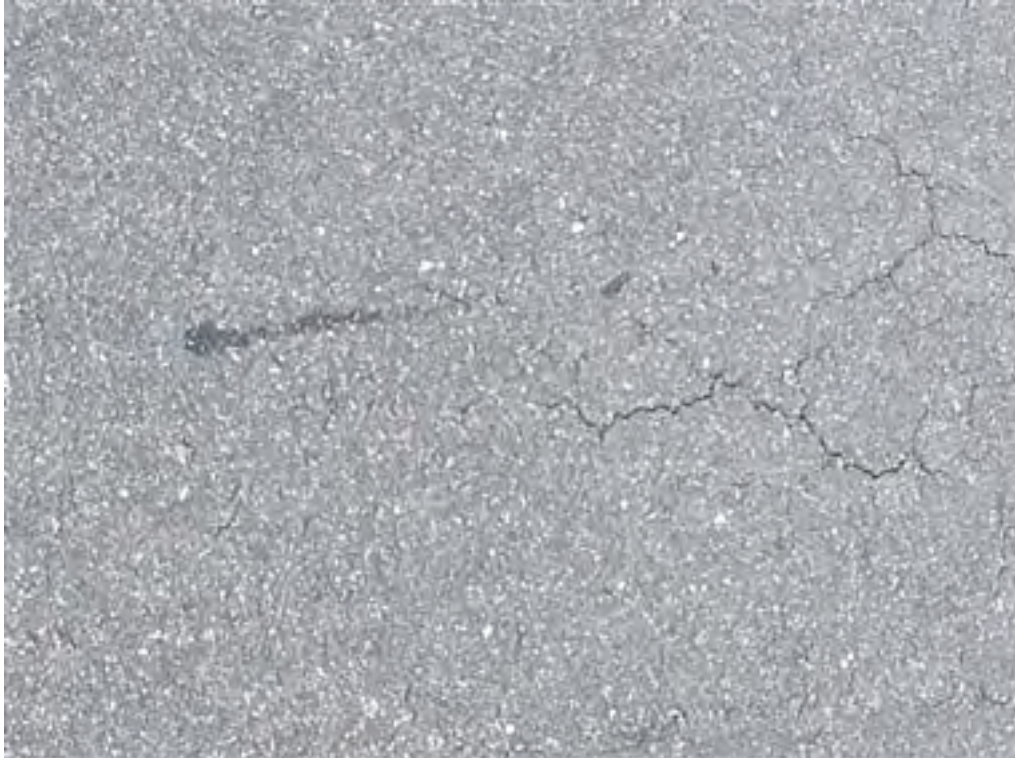
**Photo 116- asphalt paving**

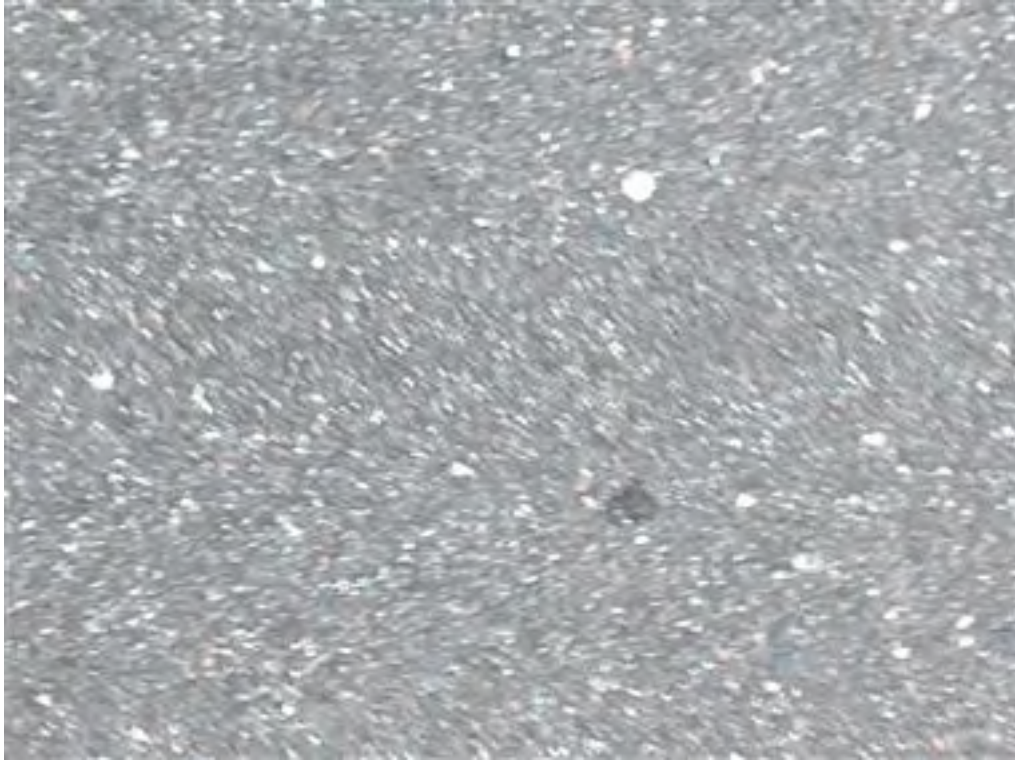
**Photo 117- asphalt paving**

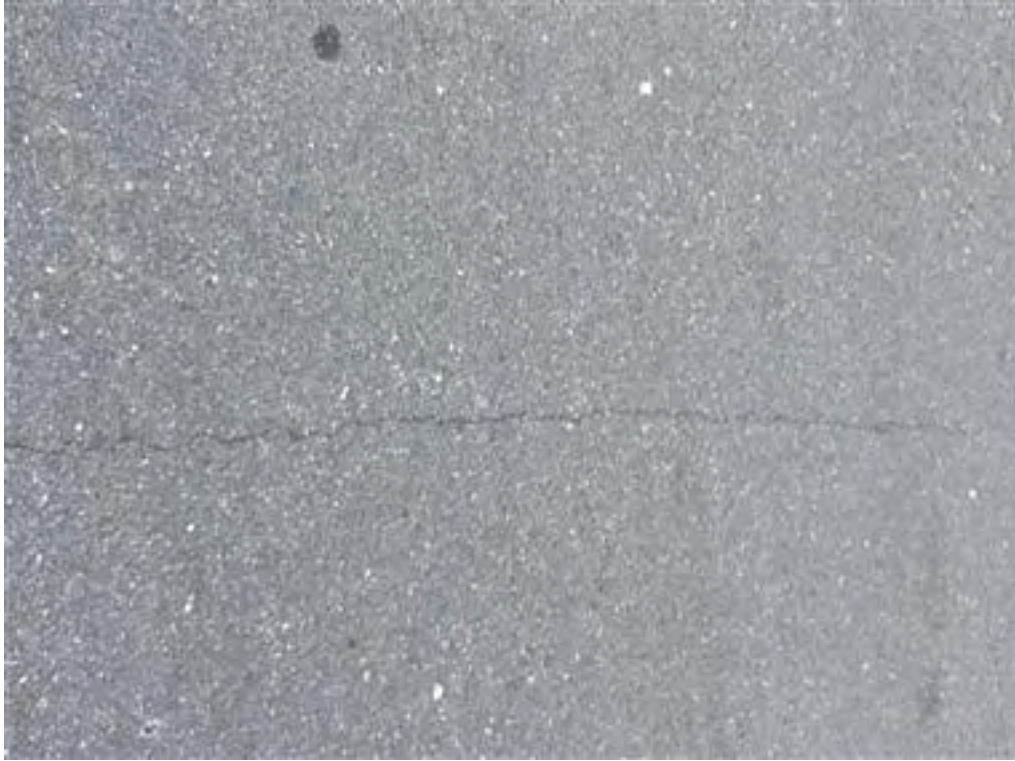
**Photo 119- asphalt paving**

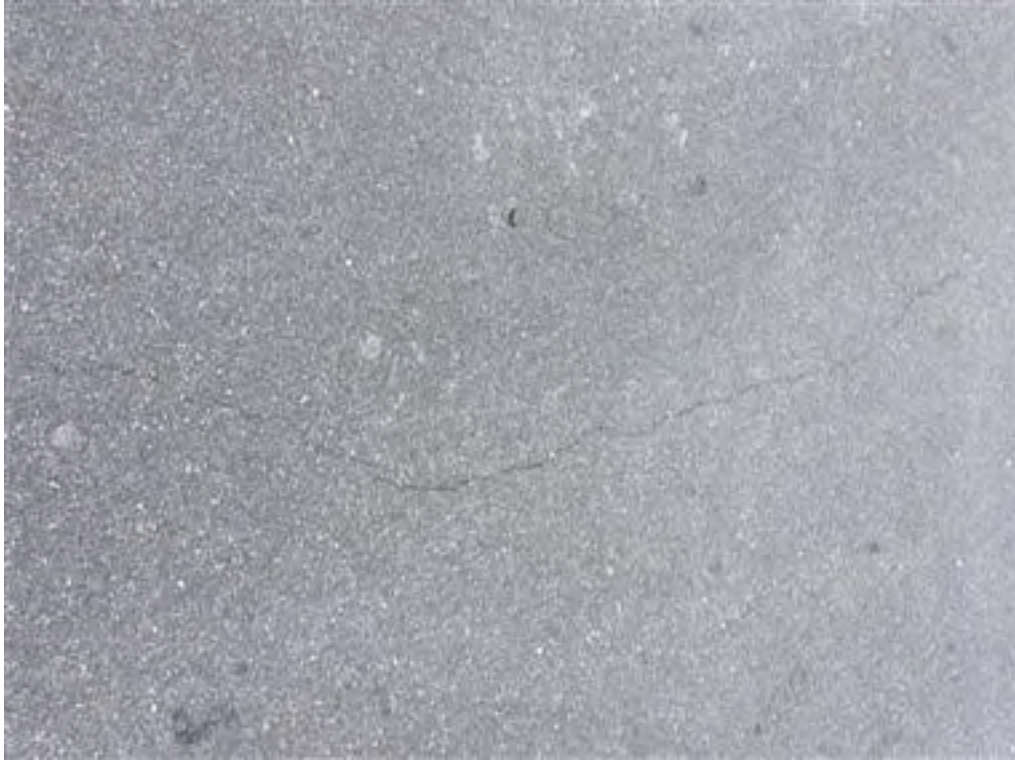
**Photo 121- asphalt paving**

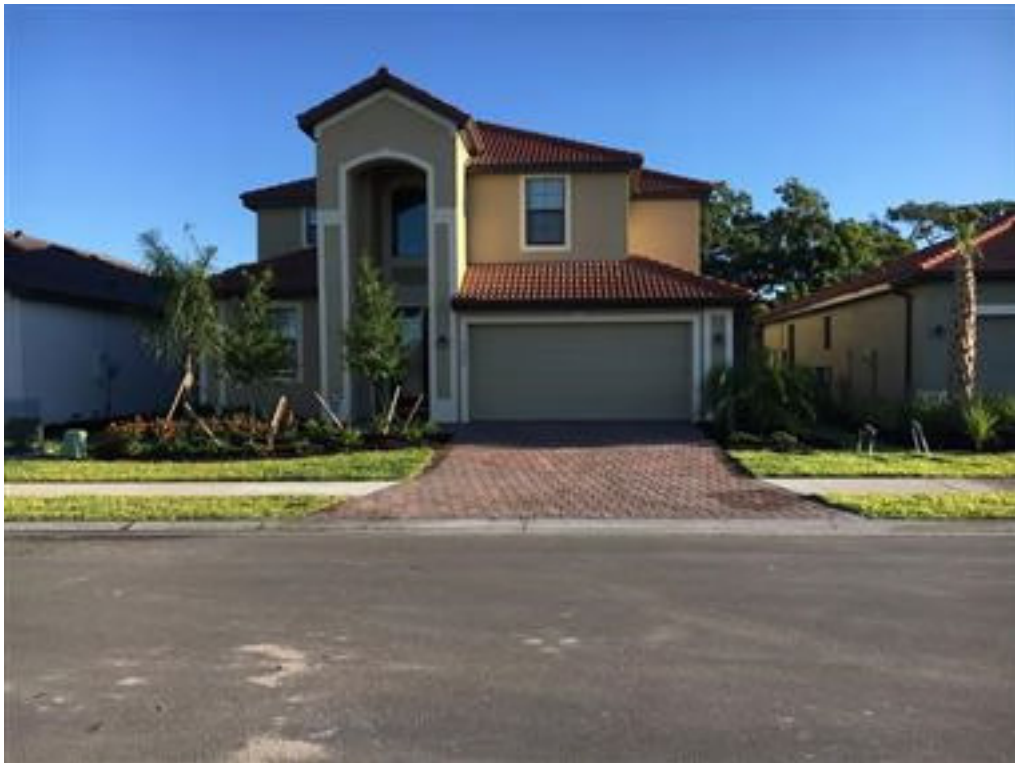
**Photo 124- swale area 9845-9841 Wingood Drive**

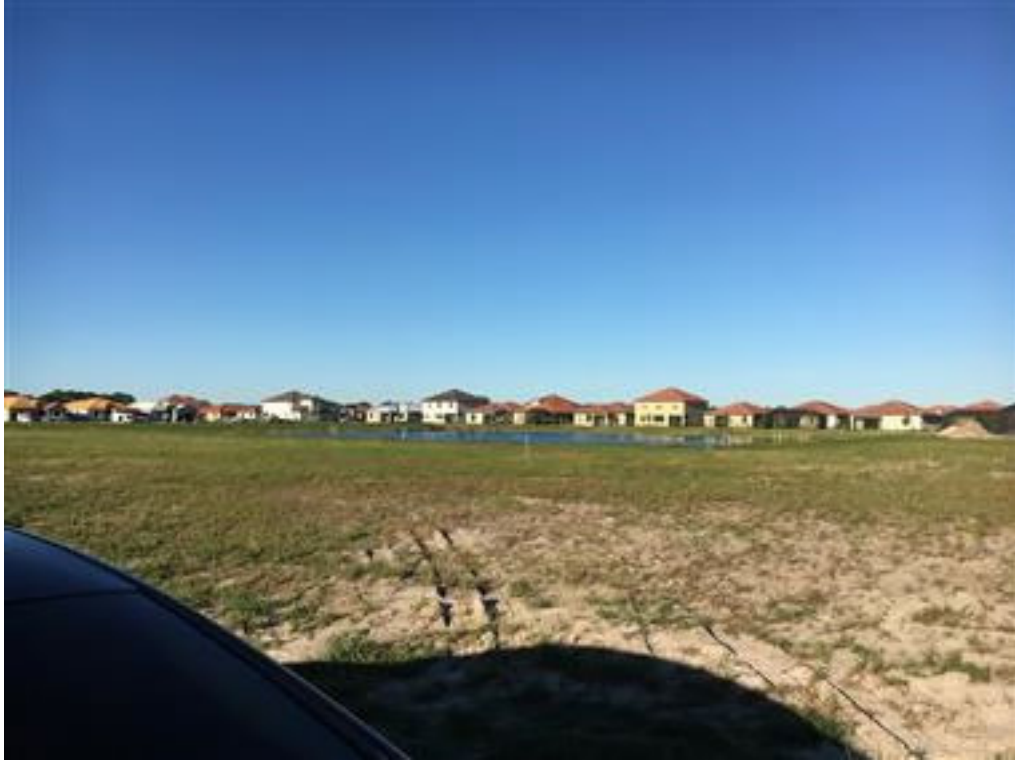
**Photo 127- swale area 19336-19340 Wingood Drive**

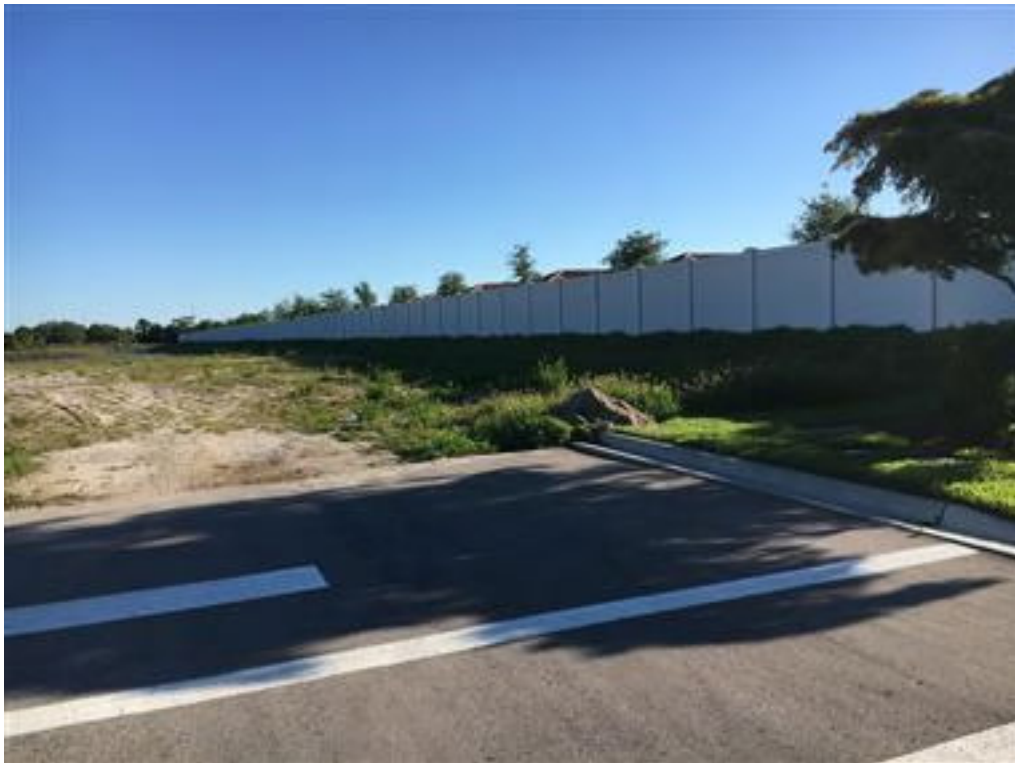
**Photo 130- sidewalk issue**
